Team Consolideck® Newsletter

Fall 2010

Consolideck[®] Profile The Grid

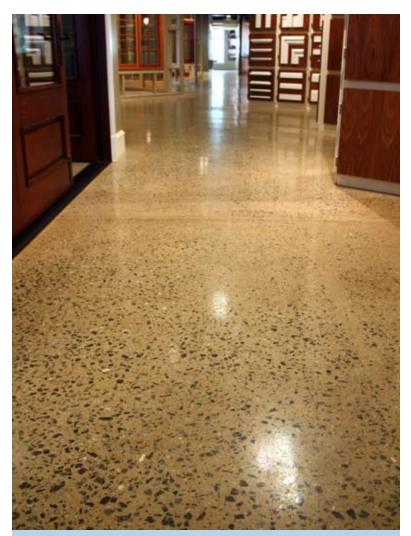
At the beginning of the project, dry-grinding revealed a handsome large, dark aggregate, hidden for years.

They started dry grinding with 30-grit metals, and moved up to 150-grit metals, removing several mils of concrete along the way. They exposed a good-looking black aggregate in some areas on their way up to 100- and 400-grit resins.
