**CMU Historic
Preservation: Kahn
Bath House**

CMU HISTORIC PRESERVATION

Kahn Bathhouse

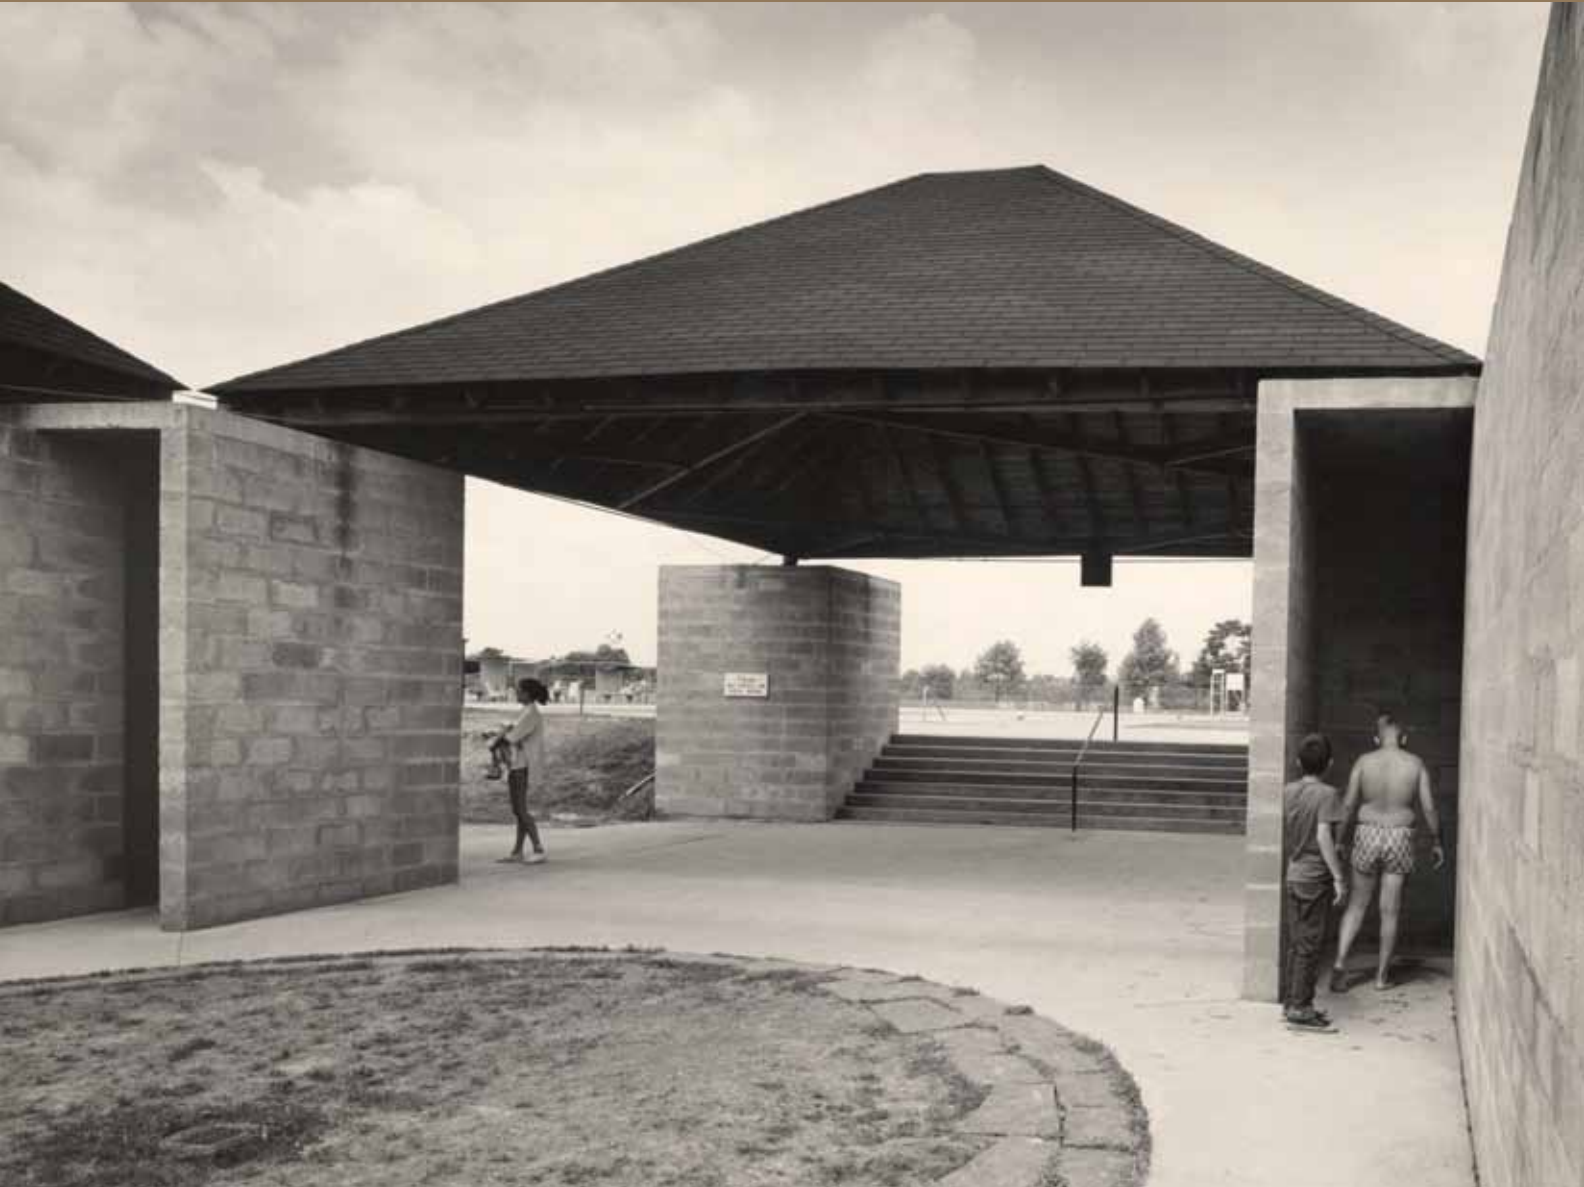
After a swim, 1955's Jewish Community Center members pass the structure's variegated block walls to enter its tranquil changing-rooms. Today, as the Ewing County Center for Seniors & Youth, it's a rare example of a restored landmark that still serves its original function.

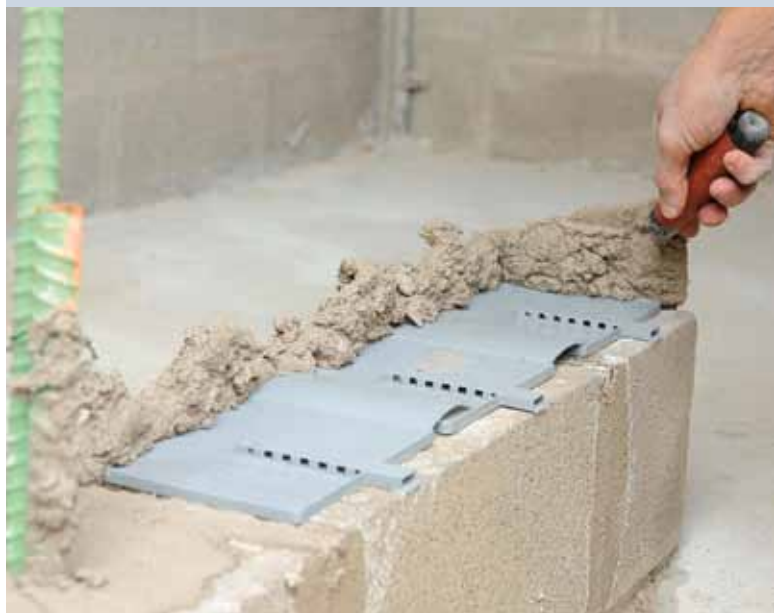
Correcting Kahn’s flashing omission with hidden 2010 technology, one of Cavalieri’s masons grouts the flashing system into place.

Since water had caused the Bath House's downfall, Michael Mills specified a couple of technologically advanced products (invisible, of course) to address those moisture-control problems. At the bases of the walls exposed to roof-runoff, Mills used a uniquely engineered proprietary flashing system. It consists of tough, lightweight "flashing pans" that are laid atop the first above-grade course of CMU and grouted into place. They intercept the water as it runs down the CMU's cores and expel it through integrated, unobtrusive drainage spouts. To capture mortar droppings, proprietary feather-light

mesh squares can be swiftly inserted into the cores of the next course of CMU, replacing awkward pea-gravel.

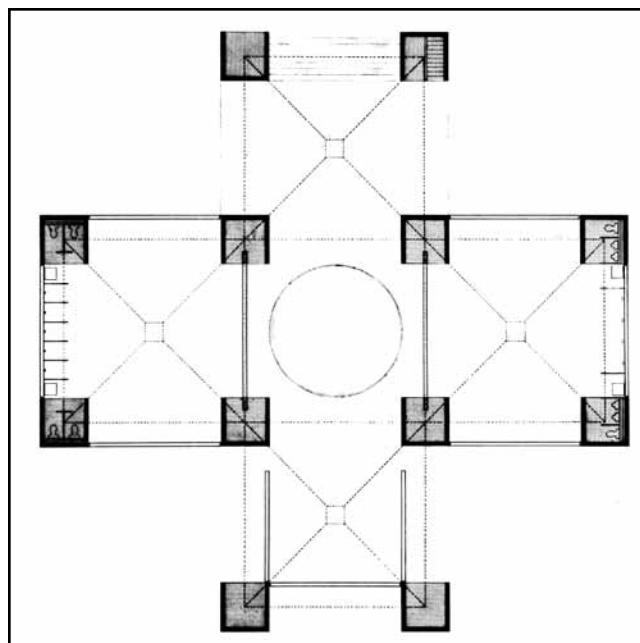
This image shows the Bath House’s classic “Greek cross” design. In two places, the edges of the suspended roofs are flush with the devising walls beneath them. Kahn envisioned rainwater pouring romantically down the unsealed, unflushed walls. It did—leading to premature wall-failure.

Two 28 foot (8.53 m) long demising walls, located where rain-water had poured directly onto them from the gutterless roofs—perhaps to let it run down the exterior in a “poetic” manner—were in dreadful shape. The top course of block had crumbled, and the walls were cracked from top to bottom.. “Those two walls were painful,” Cavalieri recalls. “Try as we might, very little of the original block could be salvaged.” The walls would be demolished and rebuilt using reproduced block. Salvageable units would be used as patchwork in other walls.

The corner-supports that held the raised roofs were strengthened. A gutter—connected into the building's drainage-system—was carefully concealed along the tops of the demising walls, to capture and divert the rainwater that had previously inundated the top courses of block. In building the new demising walls and replacing the unsalvageable units in the other walls, Cavalieri's masons used about 1,000 of the reproduced block-units.
